Yukon's Google Glass In-Service Road Safety Review Pilot

CCMTA Conference, Whitehorse, Yukon

June 2015

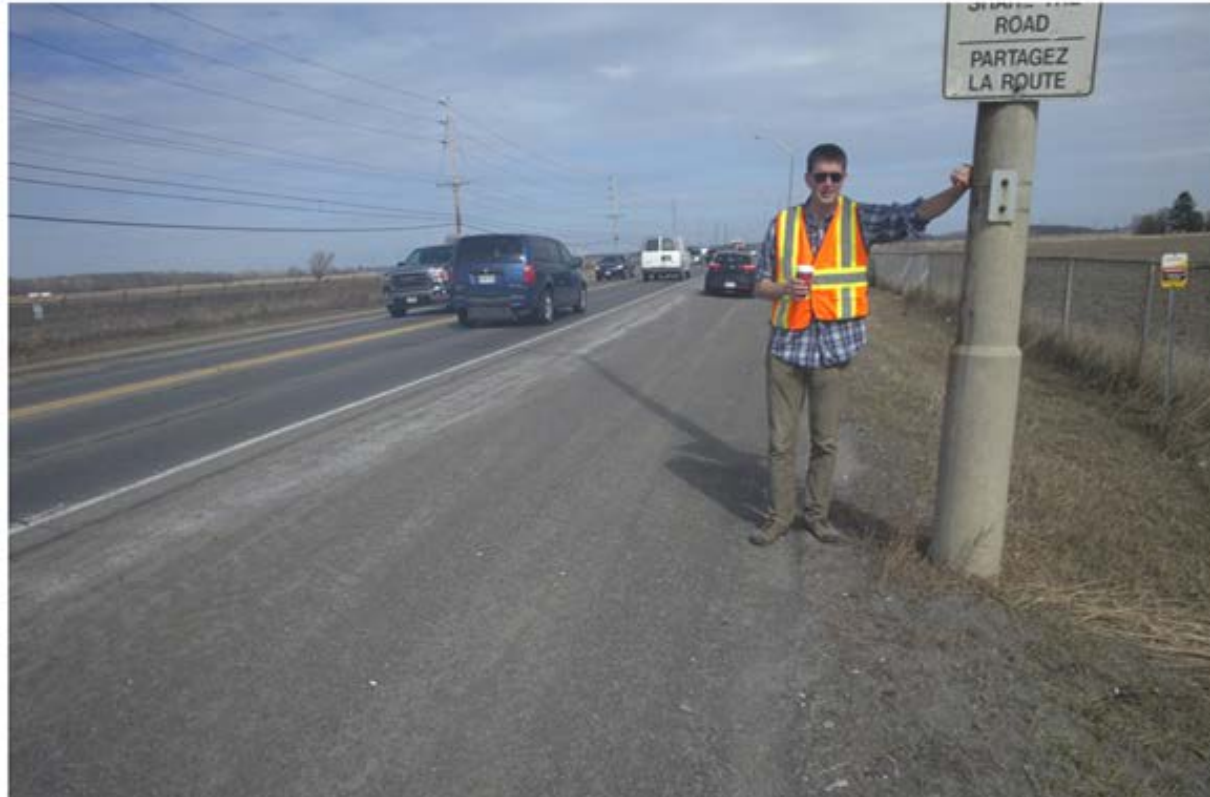
Poles on the east side of the highway are about 4 m or 4.5 m from the edge of the road.

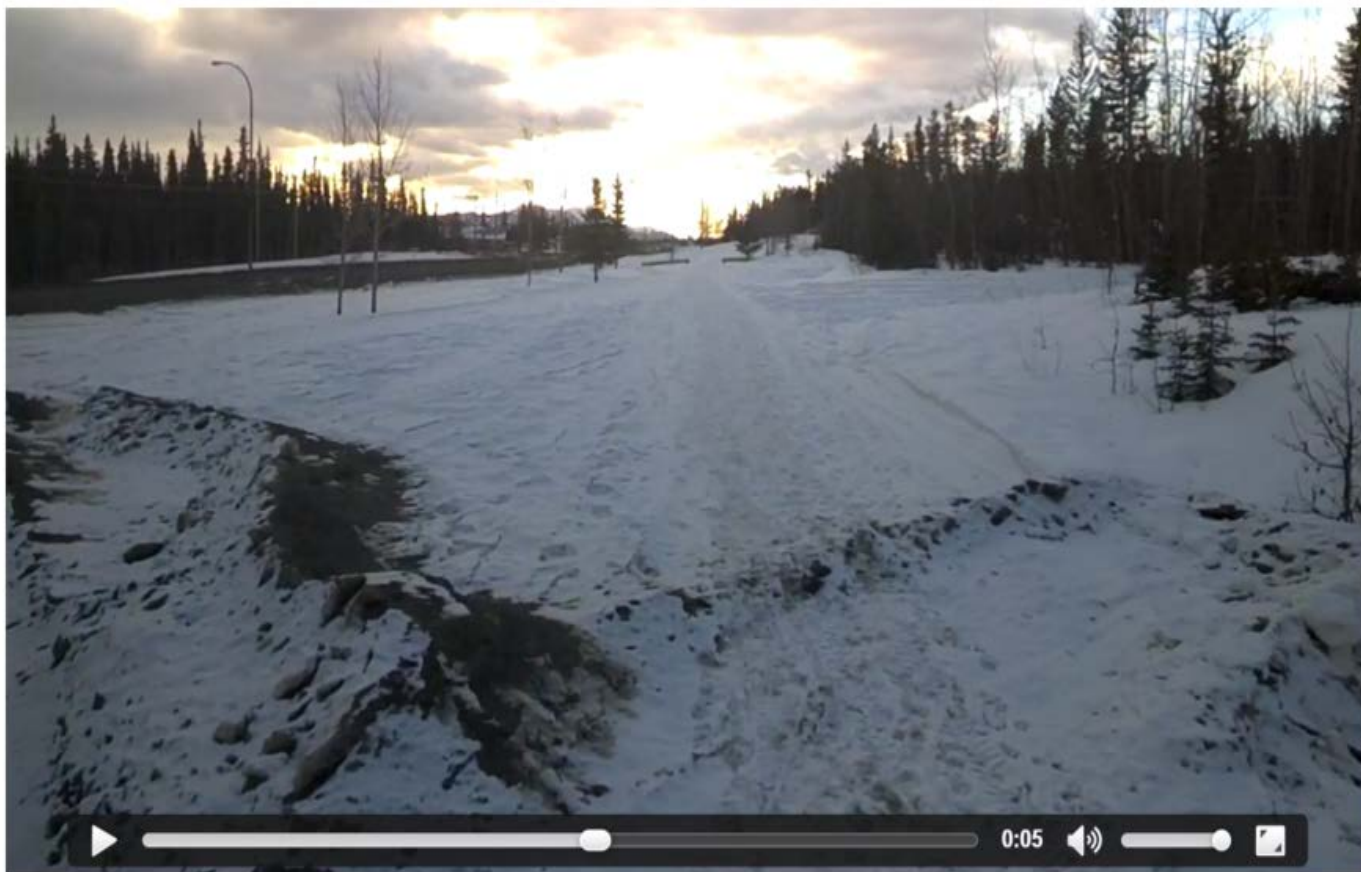
Multiuse trail that is your adjacent to Alaska Highway appears to have a significant use

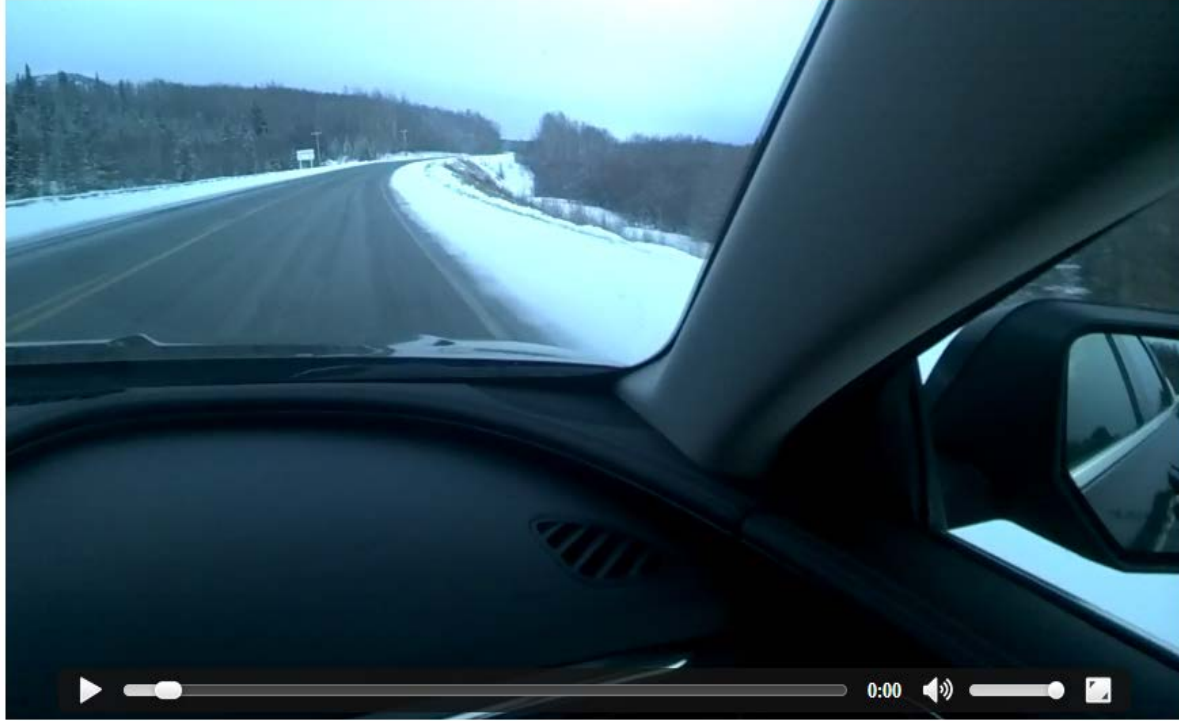
Alaska Highway N. of Teslin (10 km) – Critical Sideslopes

Start	End	L	Side	Treat
60.181465, -132.79012	60.18146, - 132.7901 (100 metres south)	100 m	SB	Flatten
60.182216, -132.79113	60.18375, - 132.7934	200 m	NB	Protect

Geometric / Issue - Video

- Critical Sideslopes → Flatten and Protect (CMF .53)
- Curve Delineation → Lines, Post-mounted reflective delineators (CMF .63)
- Intersection Conspicuity → Reflective markings
- Bump → Repair and Maintenance
- Head-on/fatigue/increased curvature after long stretch → Centre Rumble Strips (CMF .63)

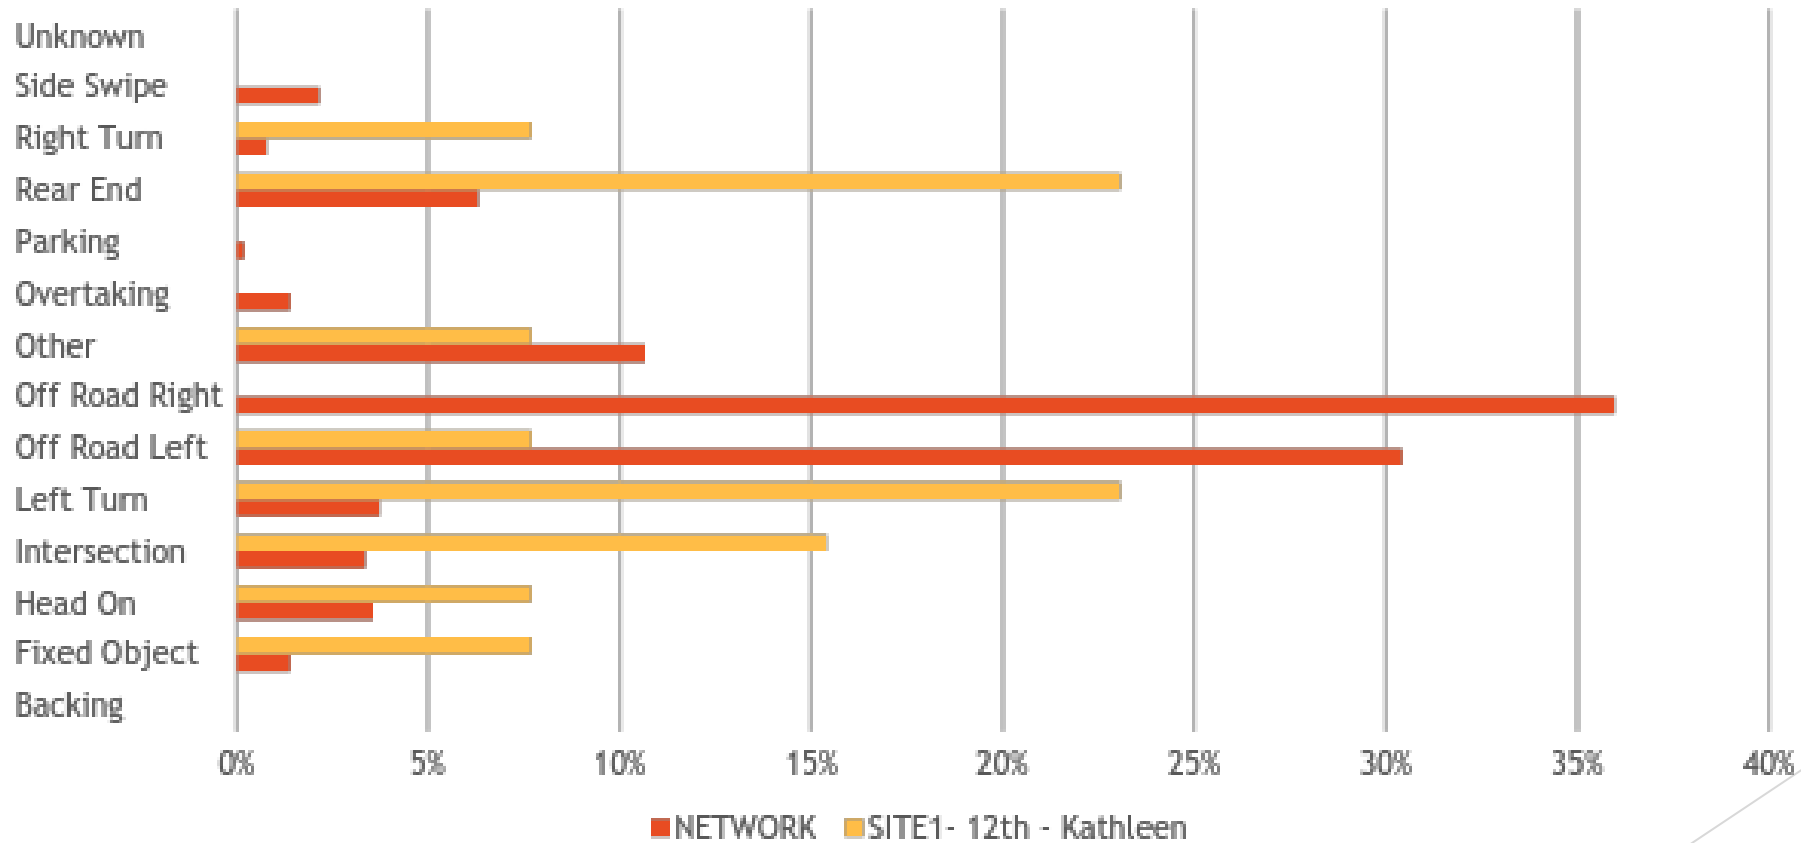
Alaska Highway - 12th Ave to Kathleen Rd - Distribution by Configuration

Distribution of FI Collisions by Configuration - Alaska Hwy from 12th Ave to Kathleen Ave

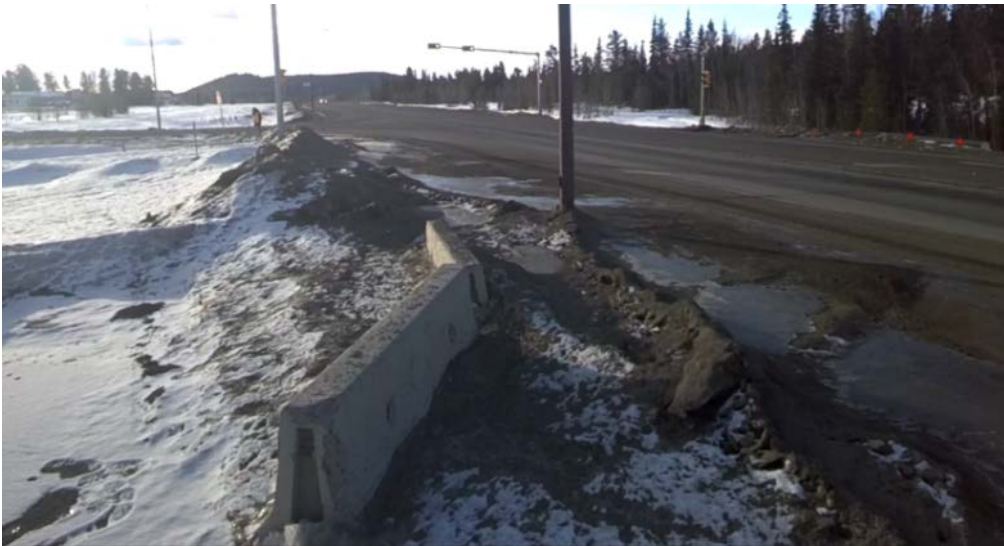
Alaska Highway - 12th Ave to Kathleen Rd – Fixed Object Hazards

- Concrete barriers placed inside clear zone just north of Wann Rd

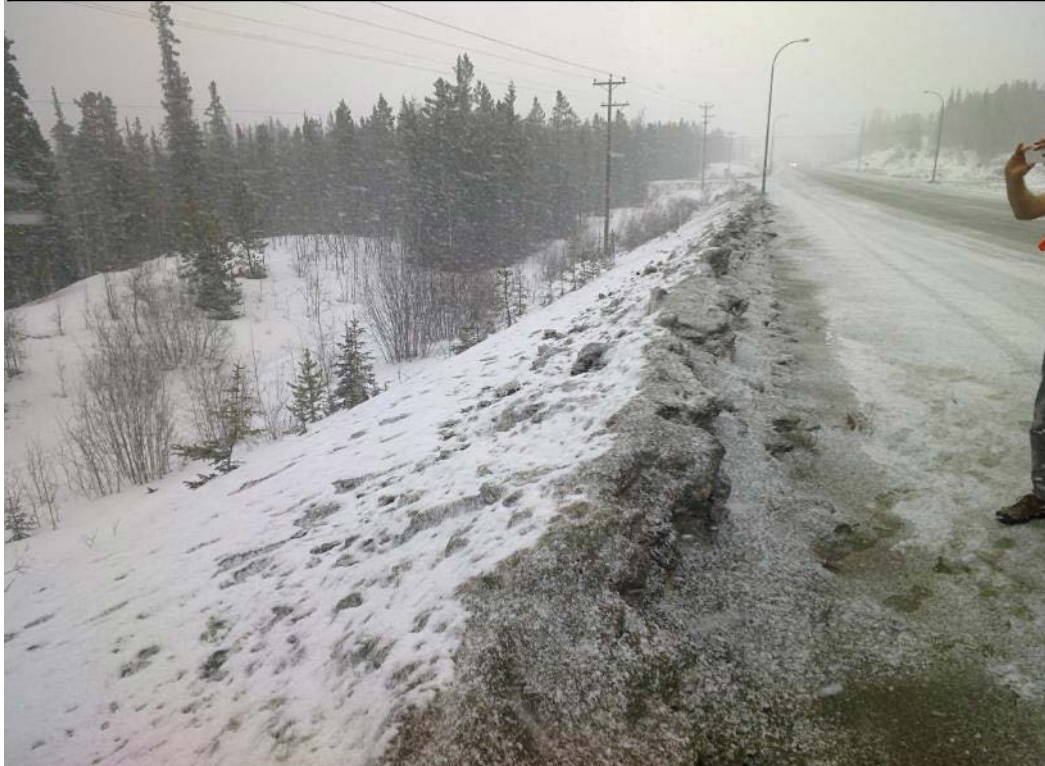
Alaska Highway – Blaker to Engelmann – Critical Sideslope

High, steep, unprotected slope with hydro poles at base

High, steep, unprotected slope with water hazard and tourist deck structure at base

High, steep, unprotected slope

Curve on downgrade traveling southbound;
outside of curve has high, steep,
unprotected slope

- Critical Sideslopes → Curve delineation markers (CMF .81), shoulder rumble strips (CMF .84), roadside barrier (CMF 0.56)
- Deteriorated Signage → Replace signs (CMF .946)
- Illumination → Provide Illumination between Engelmann and Dr. and Castle Dr. (CMF 0.72)
- Auxiliary Lane Use → Correct signs and pavement markings

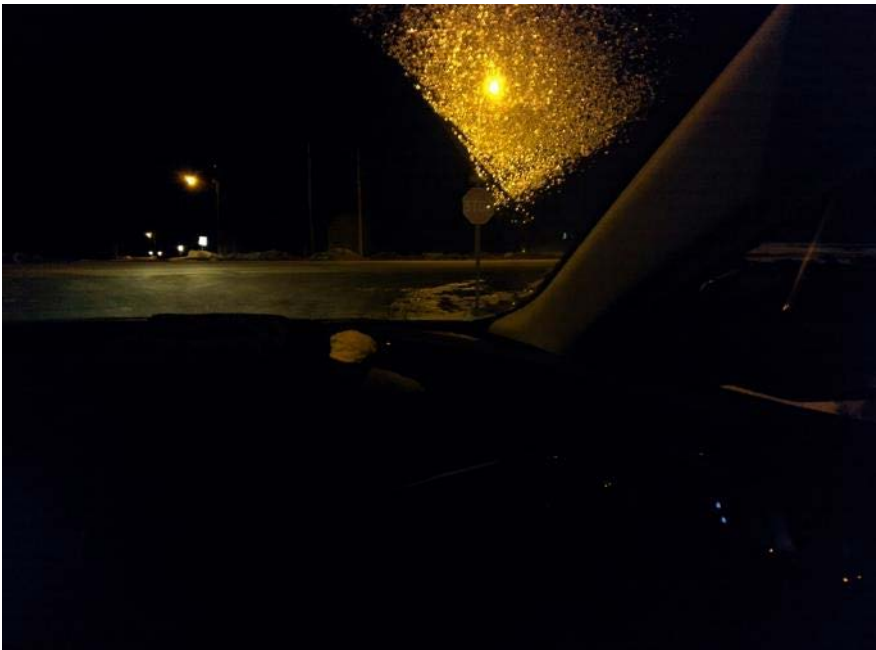
Alaska Highway – Blaker to Engelmann – Deteriorated Signage

- Stop sign at Cronkite has deteriorated retroreflectivity
