Proposed solution to improve pedestrian detection in urban areas by heavy vehicle drivers

By Sébastien Bédard, Eng., M.Sc
CCMTA Annual Meeting
June 3, 2018

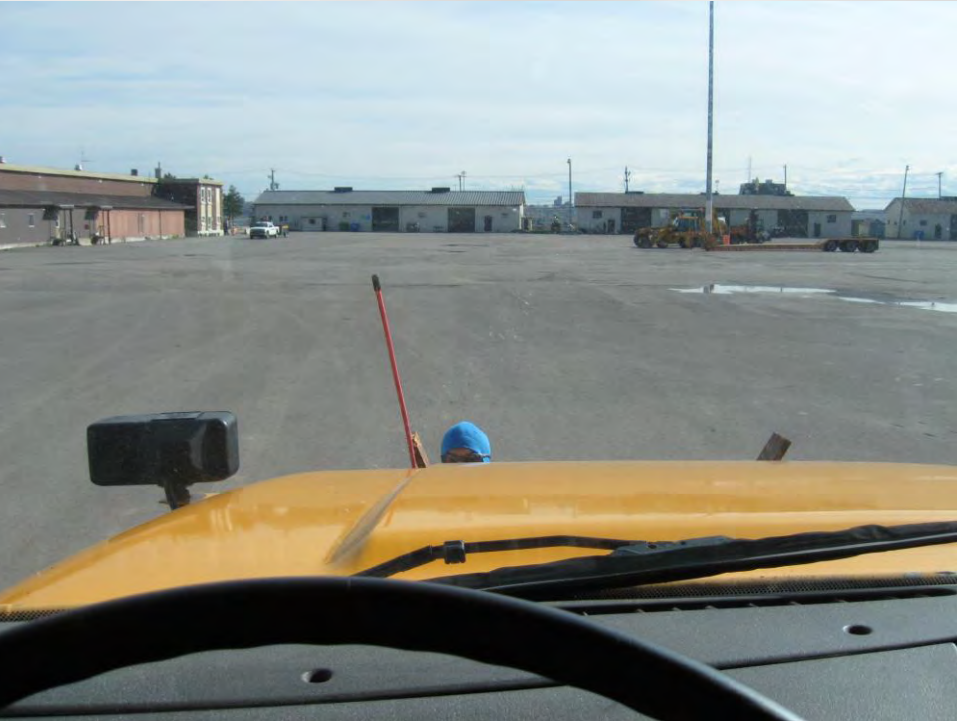
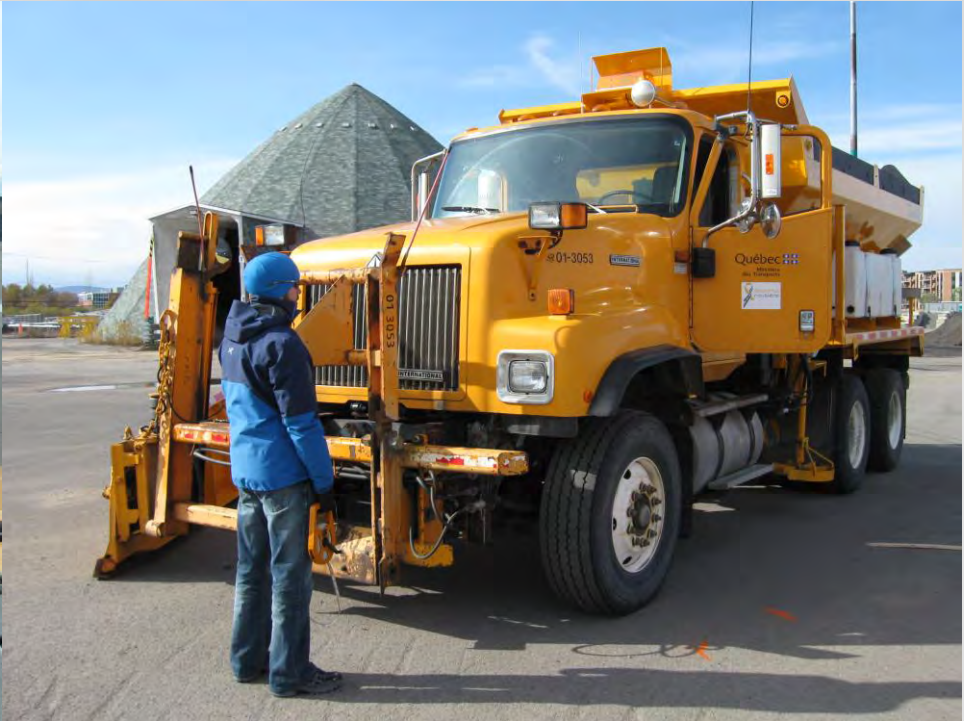
Example of a front blind spot

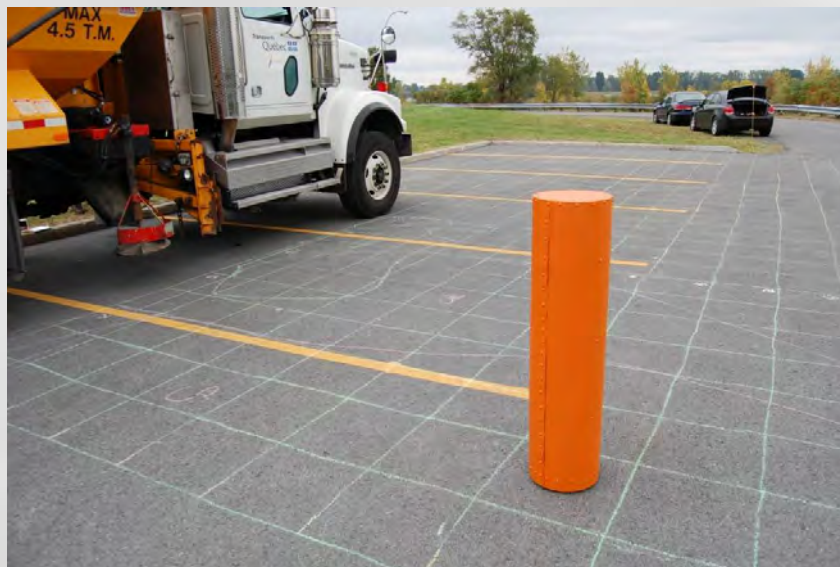
- Pedestrian: 6-year-old child (50th percentile)
- Cylinder approximately 115 cm (45 in.) tall
- Detection in a mirror = cylinder completely visible

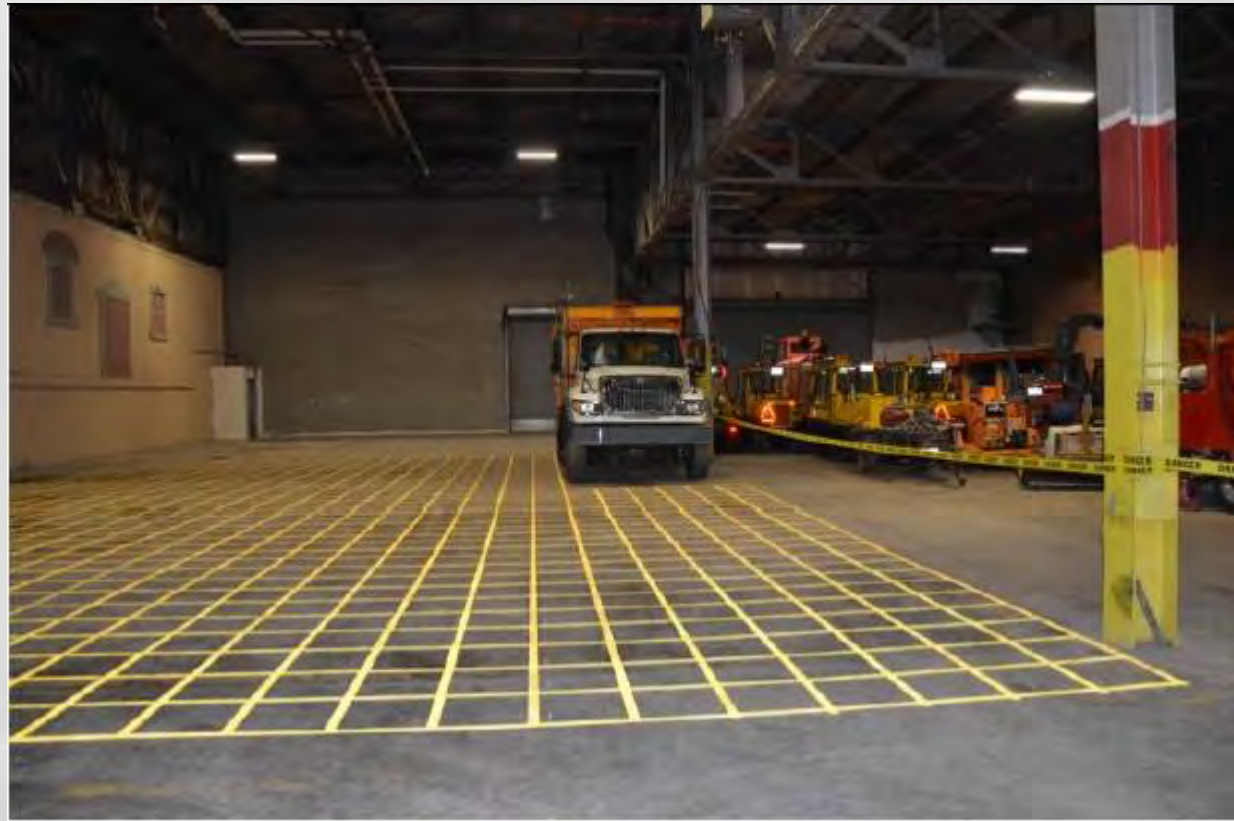
- Ville de Montréal warehouse
- Grid pattern floor
- Interior
- Adjustable lighting

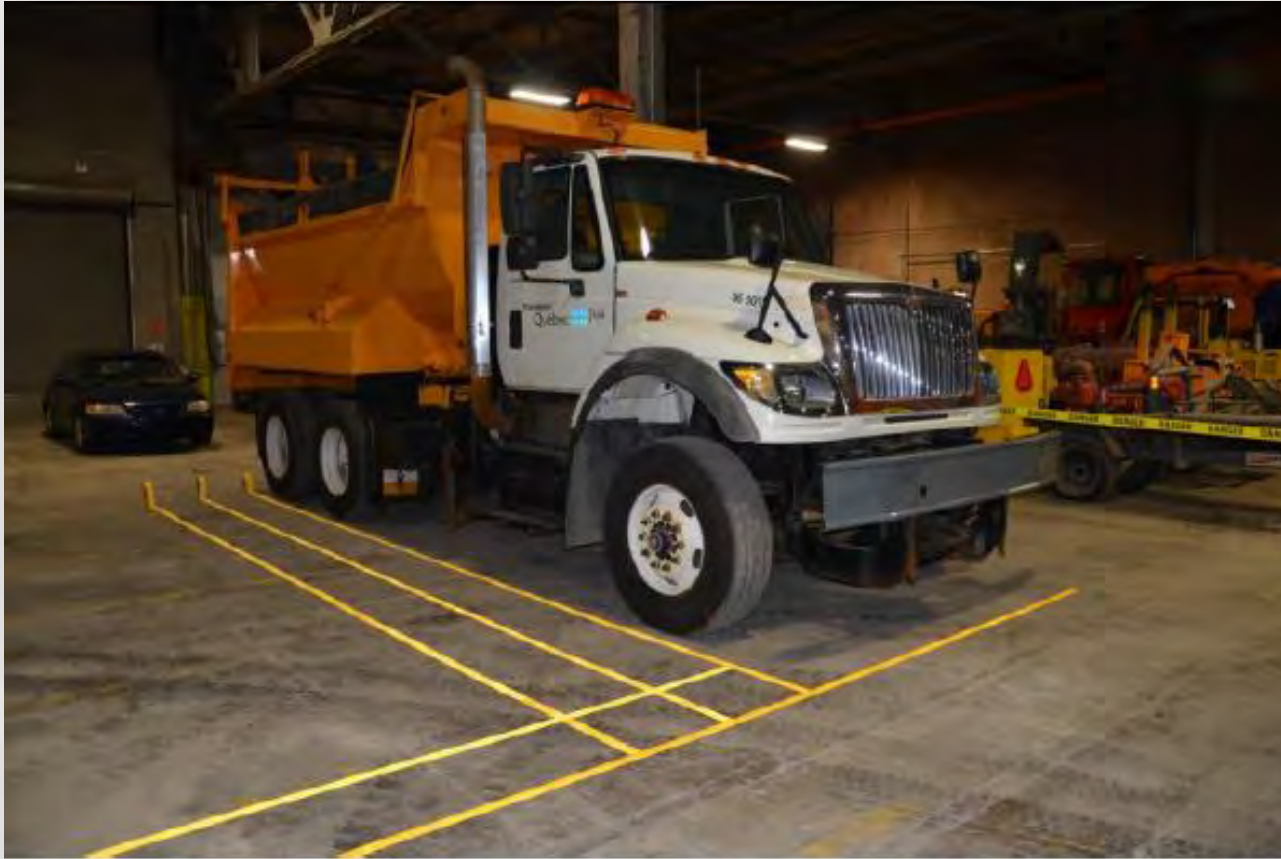
- 1 vehicle: International 7600 (MTMDET)

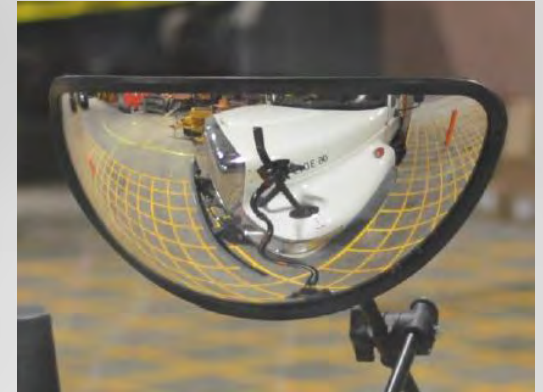
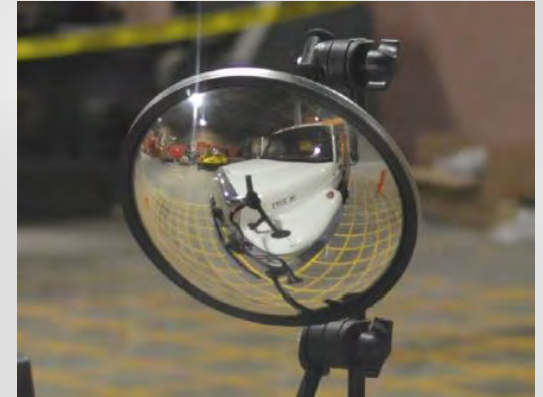
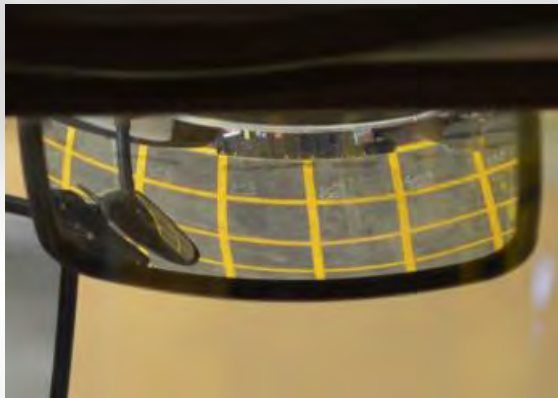
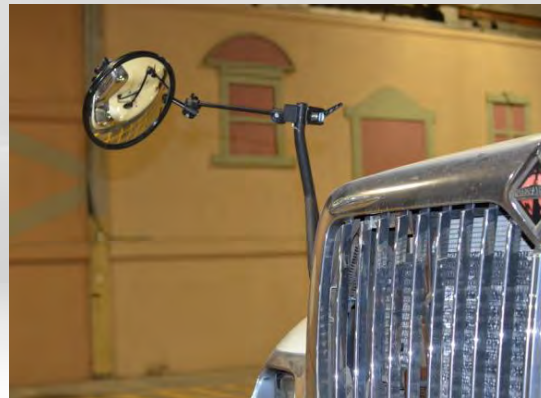
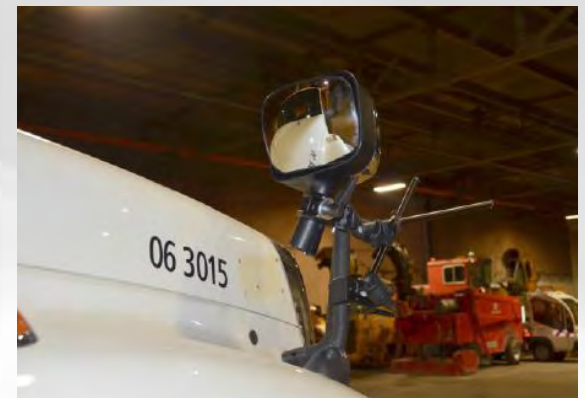
16 mirrors separated into 5 categories

1. School bus mirrors (standardized)
2. Other types of front mirrors
3. Convex mirror on each fender
4. Front-view mirror only
5. Mirror above passenger-side door

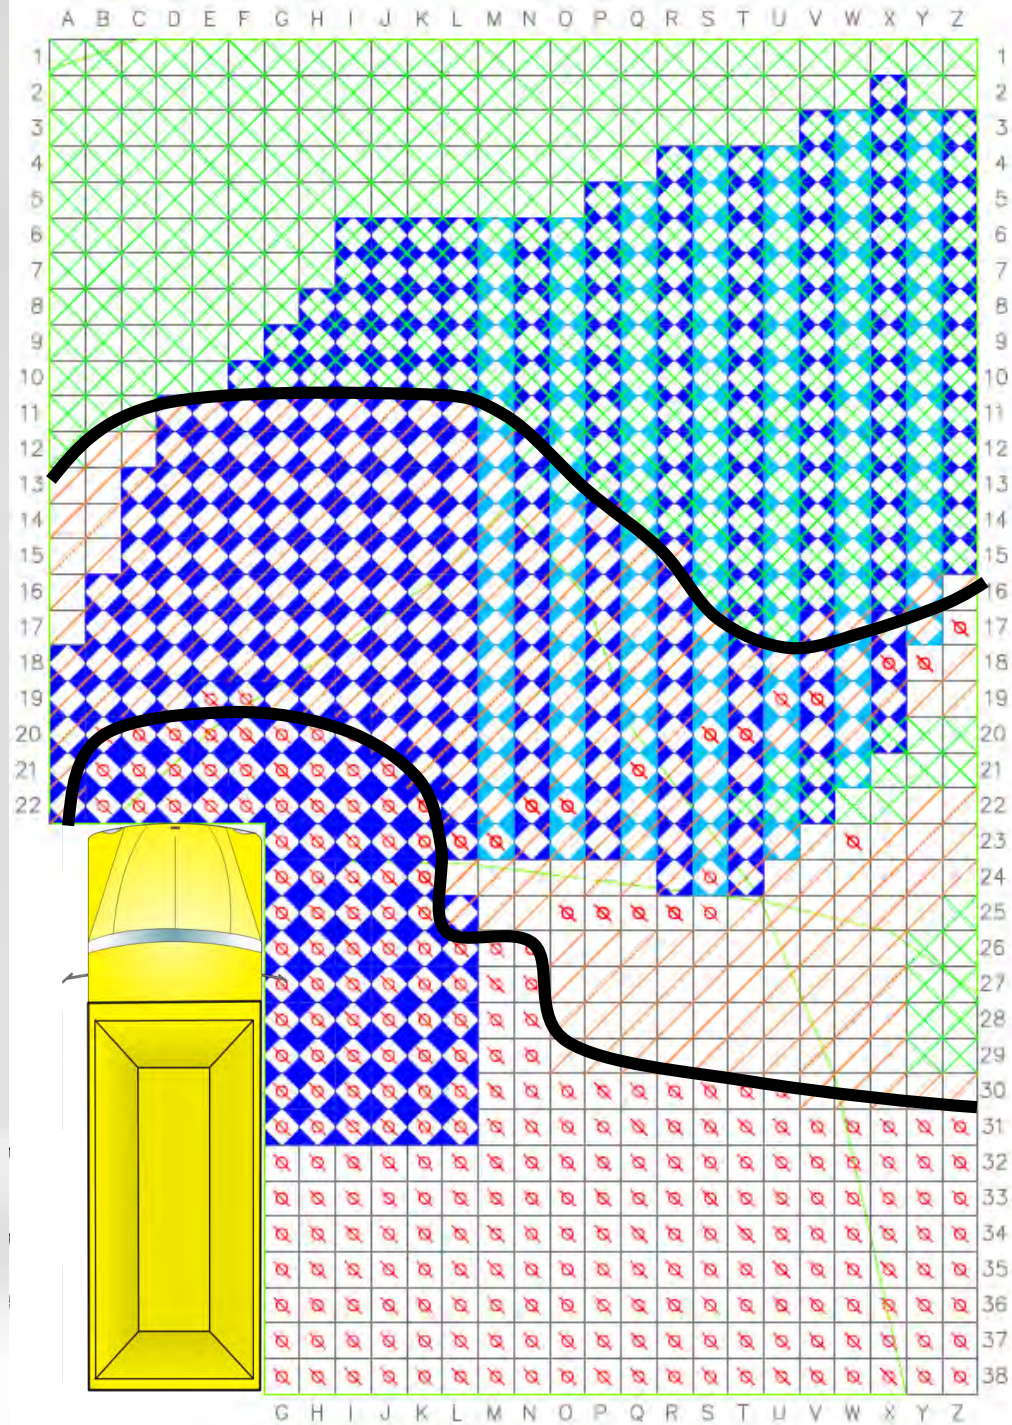
Type 2: Others

Adjustment

- Impossible to adjust to the school bus standard
- Tandem method: Adjusted to the right of the two front mirrors

- Combination of two front mirrors
- **The adjustment method is very important**

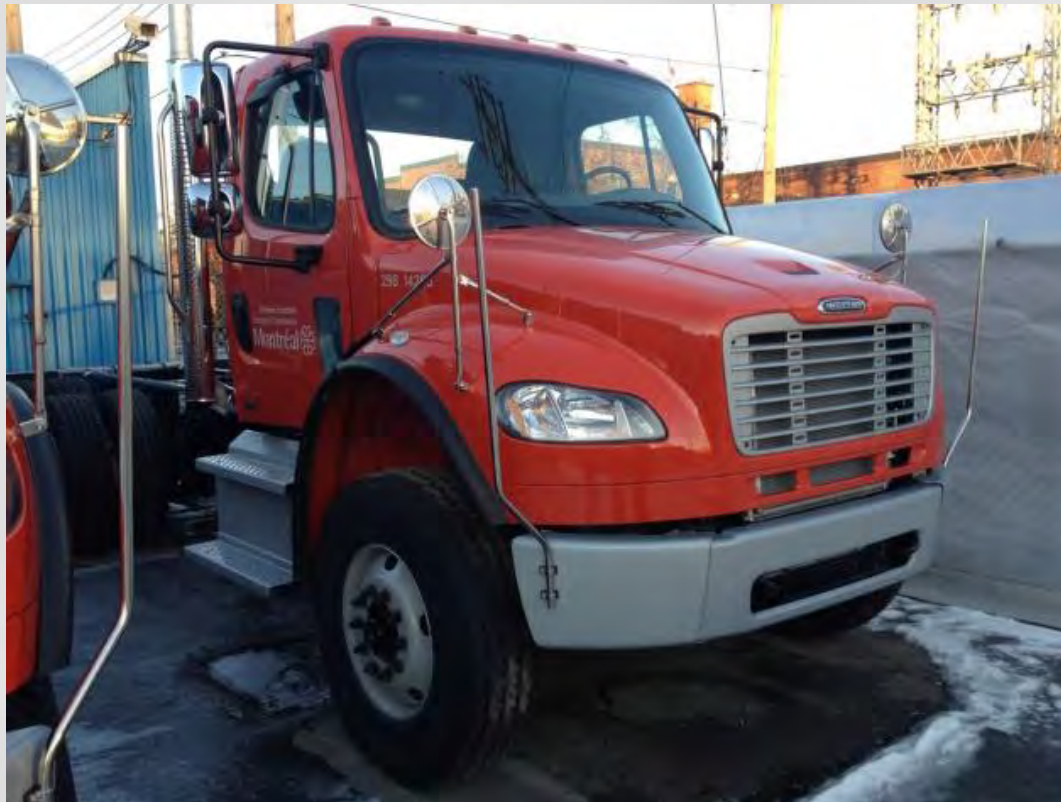
- Different vehicle: Freightliner M2-106 (Ville de Montréal)

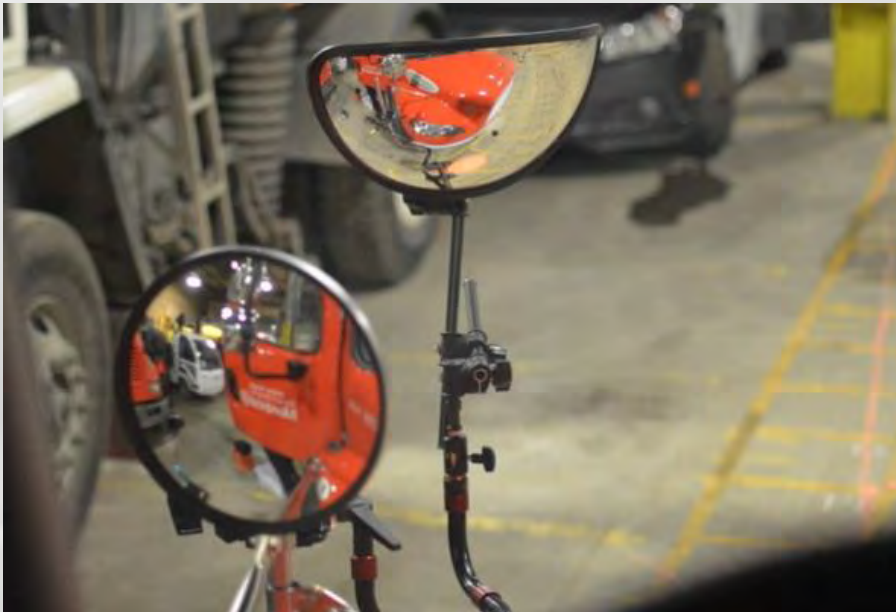
Left

- 2 Safety Crossview mirrors, adjusted per the hybrid method

- Assess a “hybrid” adjustment
 - Left-hand mirror: school bus adjustment
 - Right-hand mirror: adjusted per the tandem method
- Carry out testing in other environmental conditions

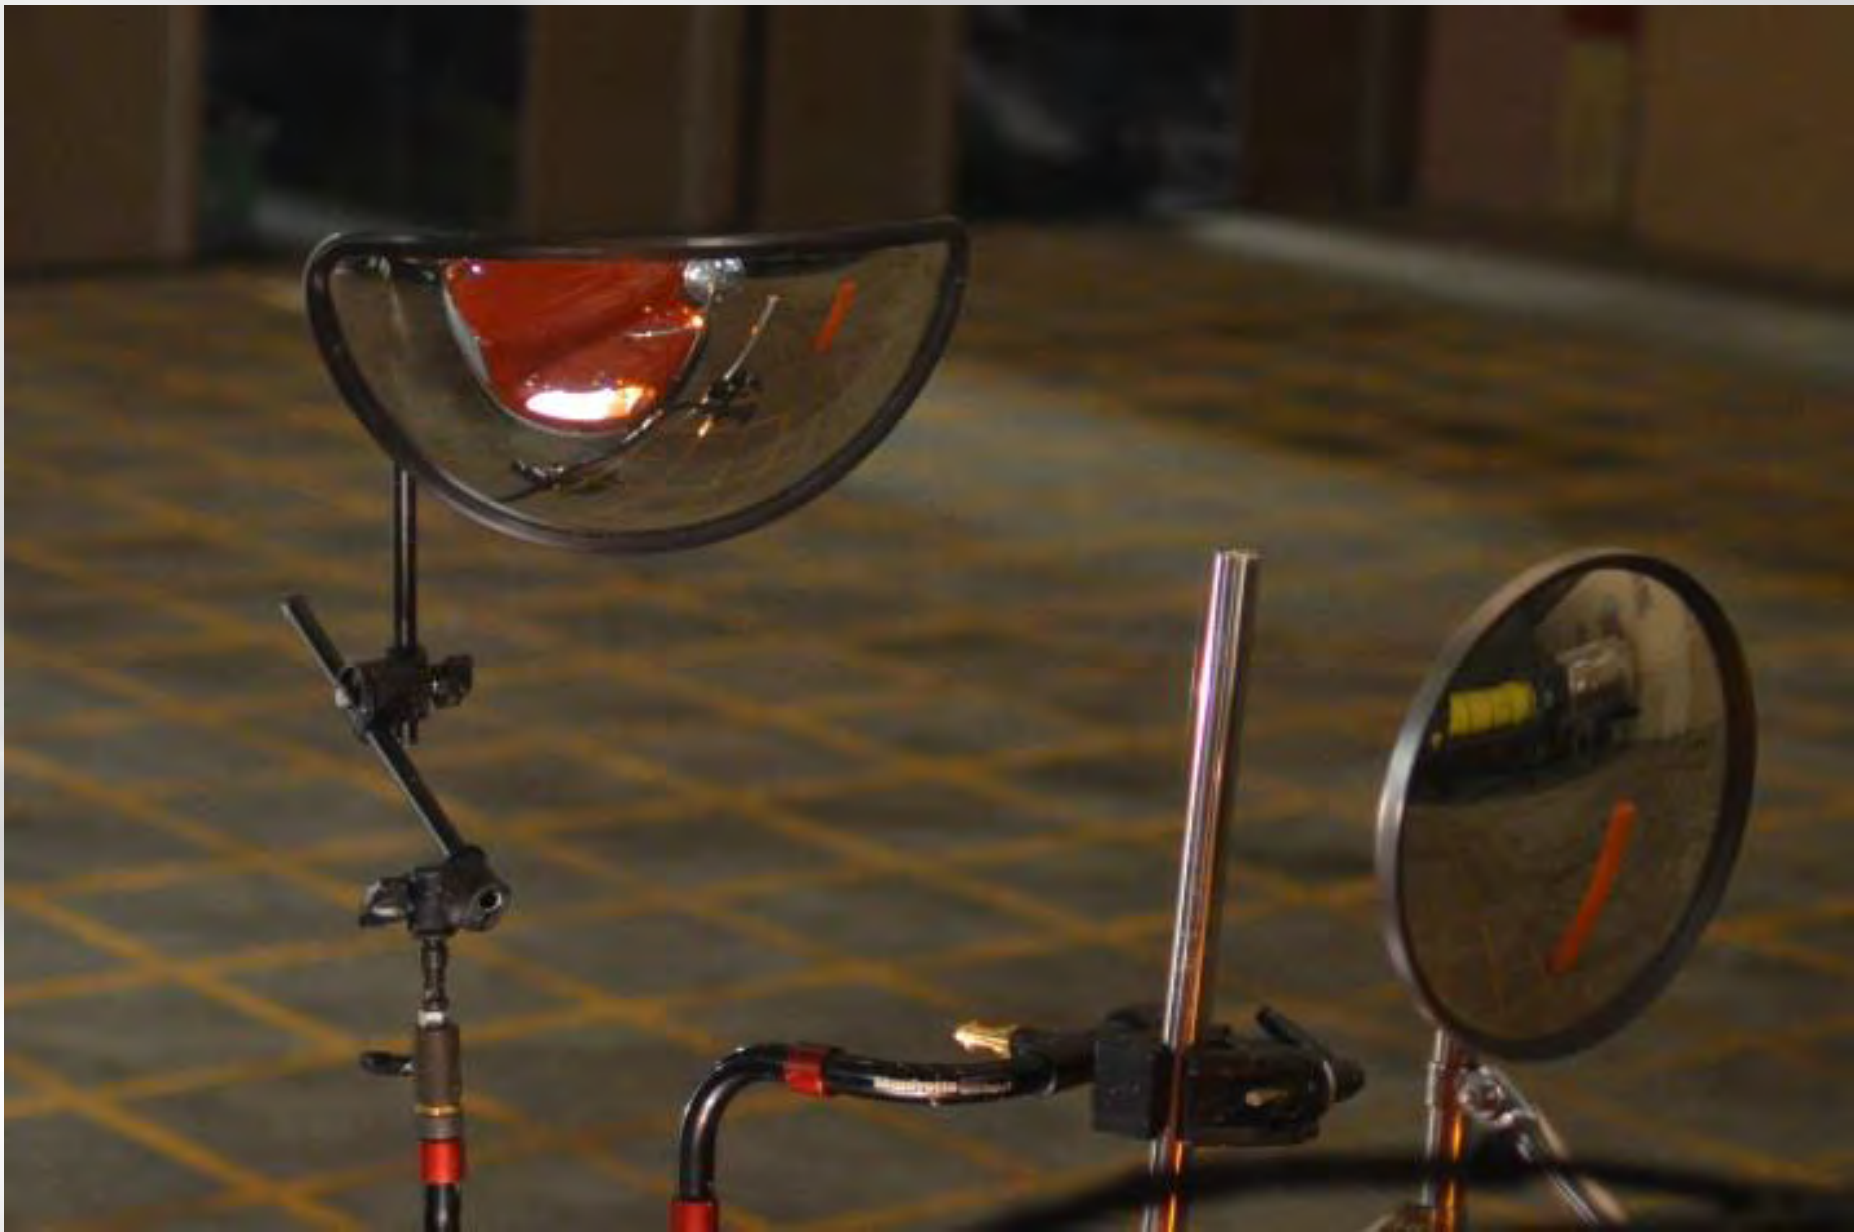
Scenario - Night

Night: Slight decrease

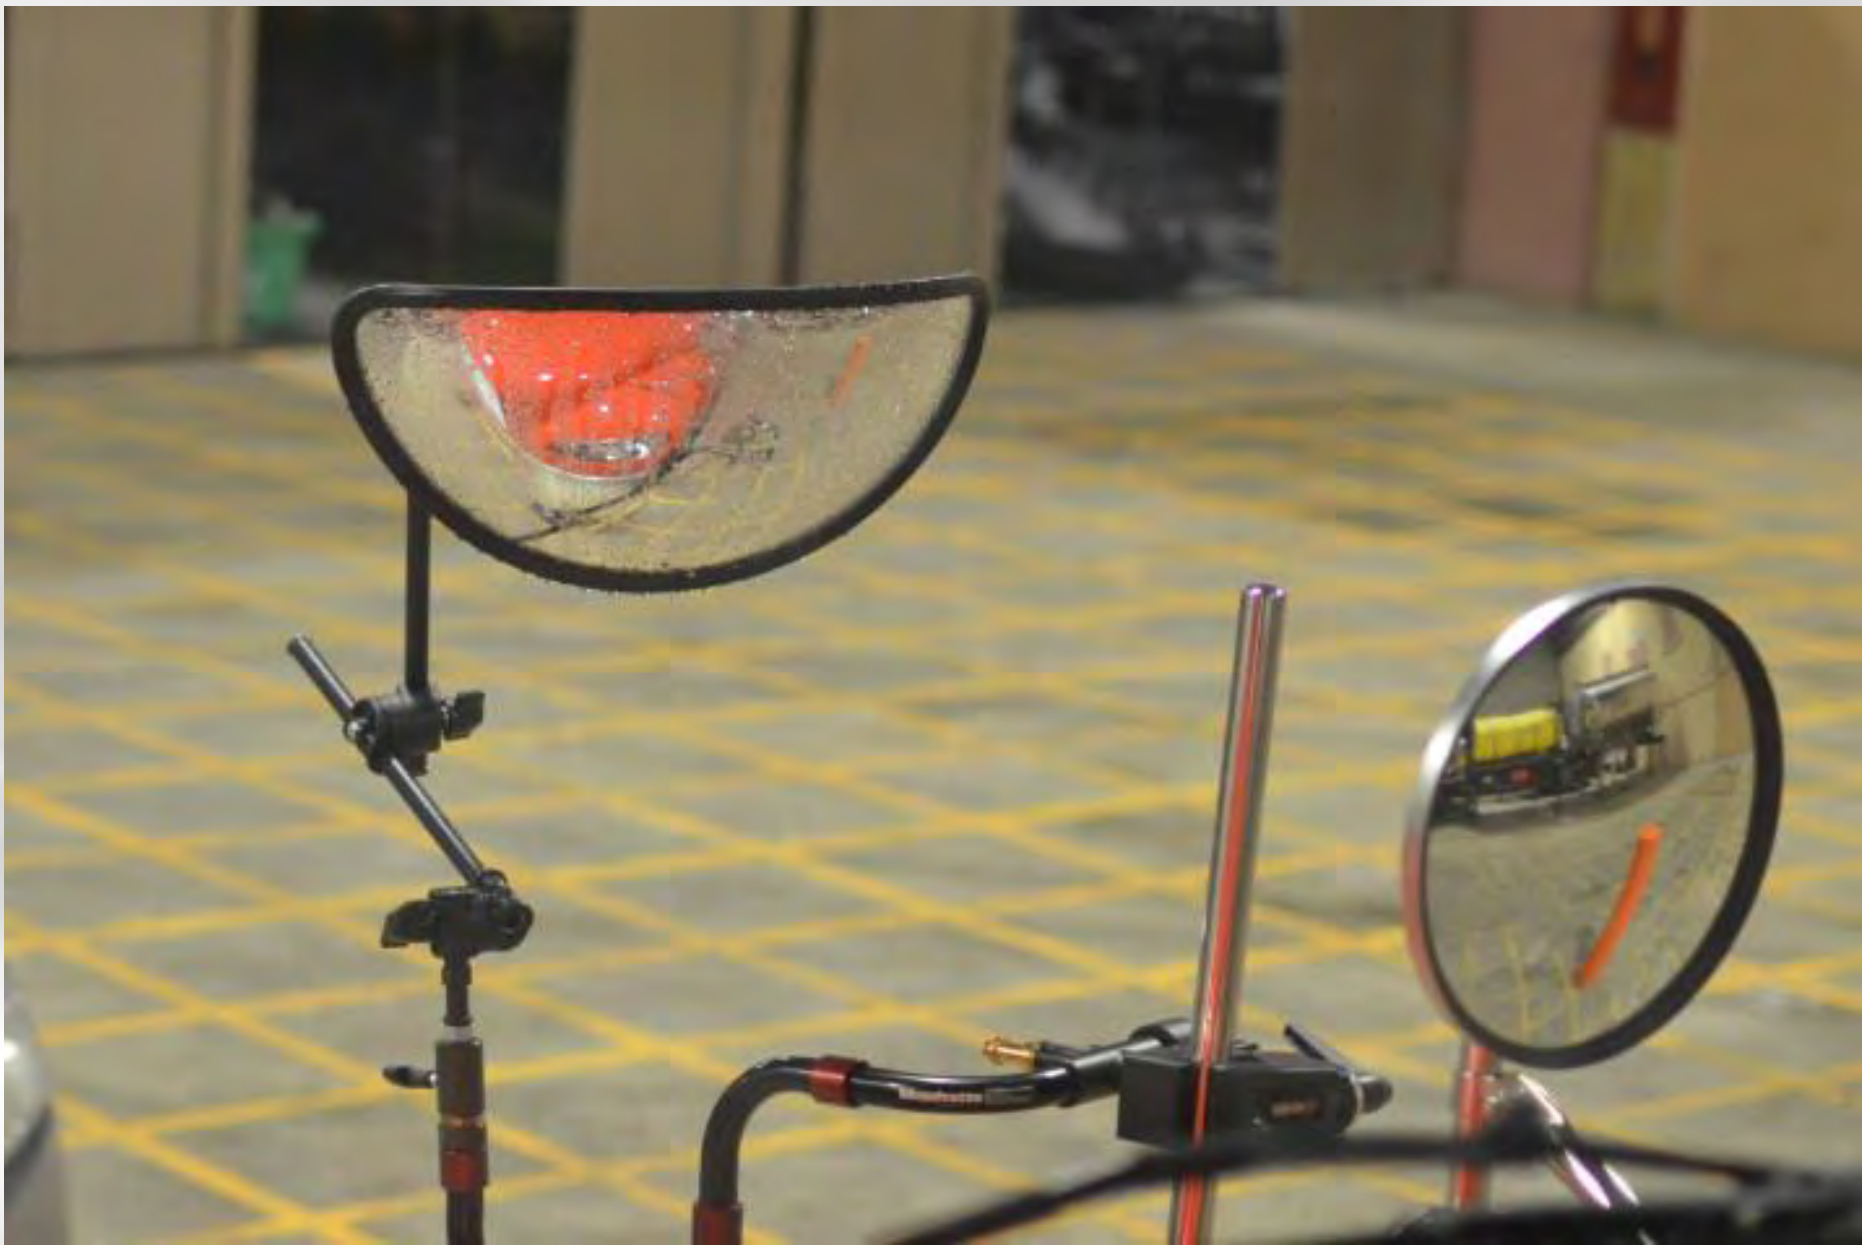
Scenario - Rainy day

Day – rainy: Large decrease

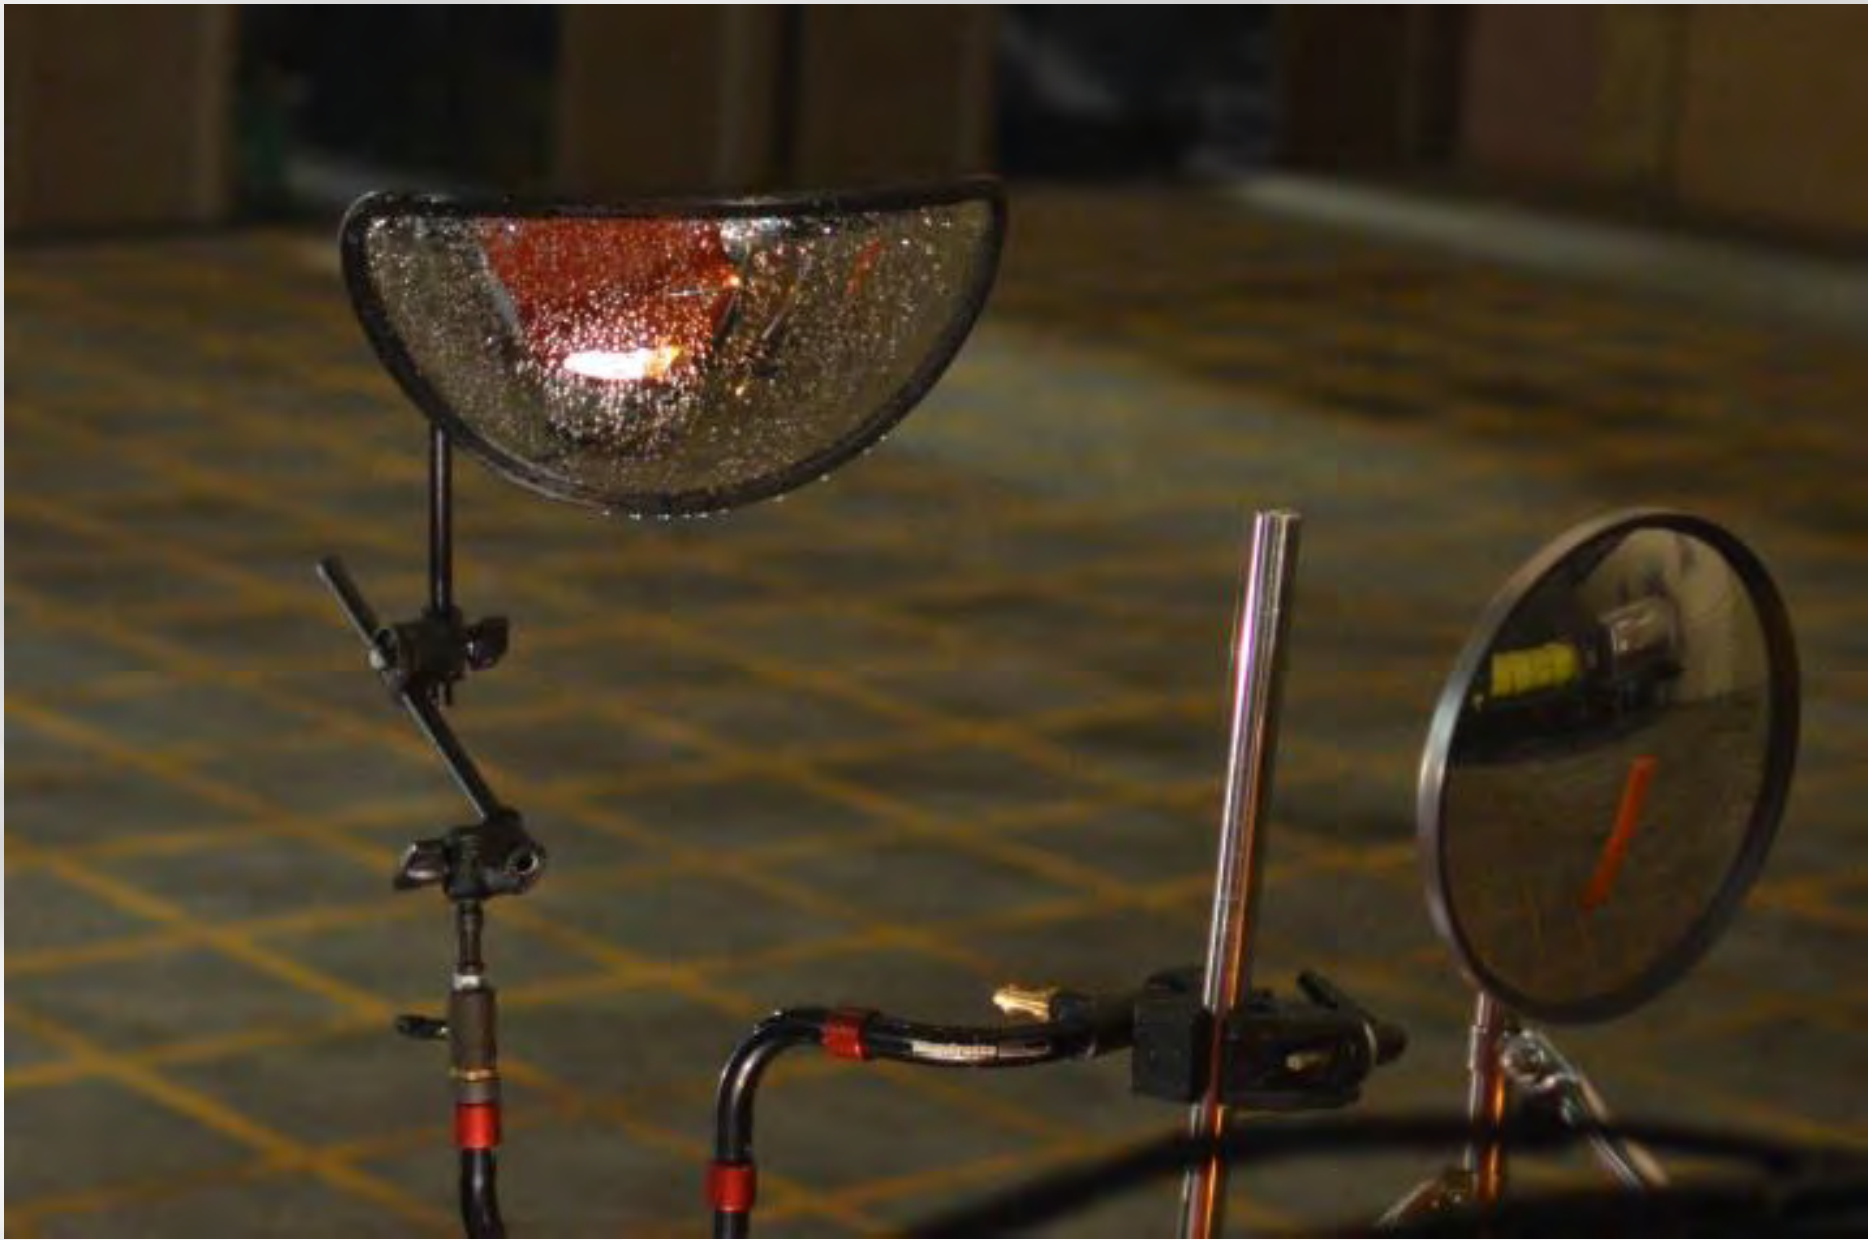
Scenario - Rainy night

Night – rainy: Very large decrease

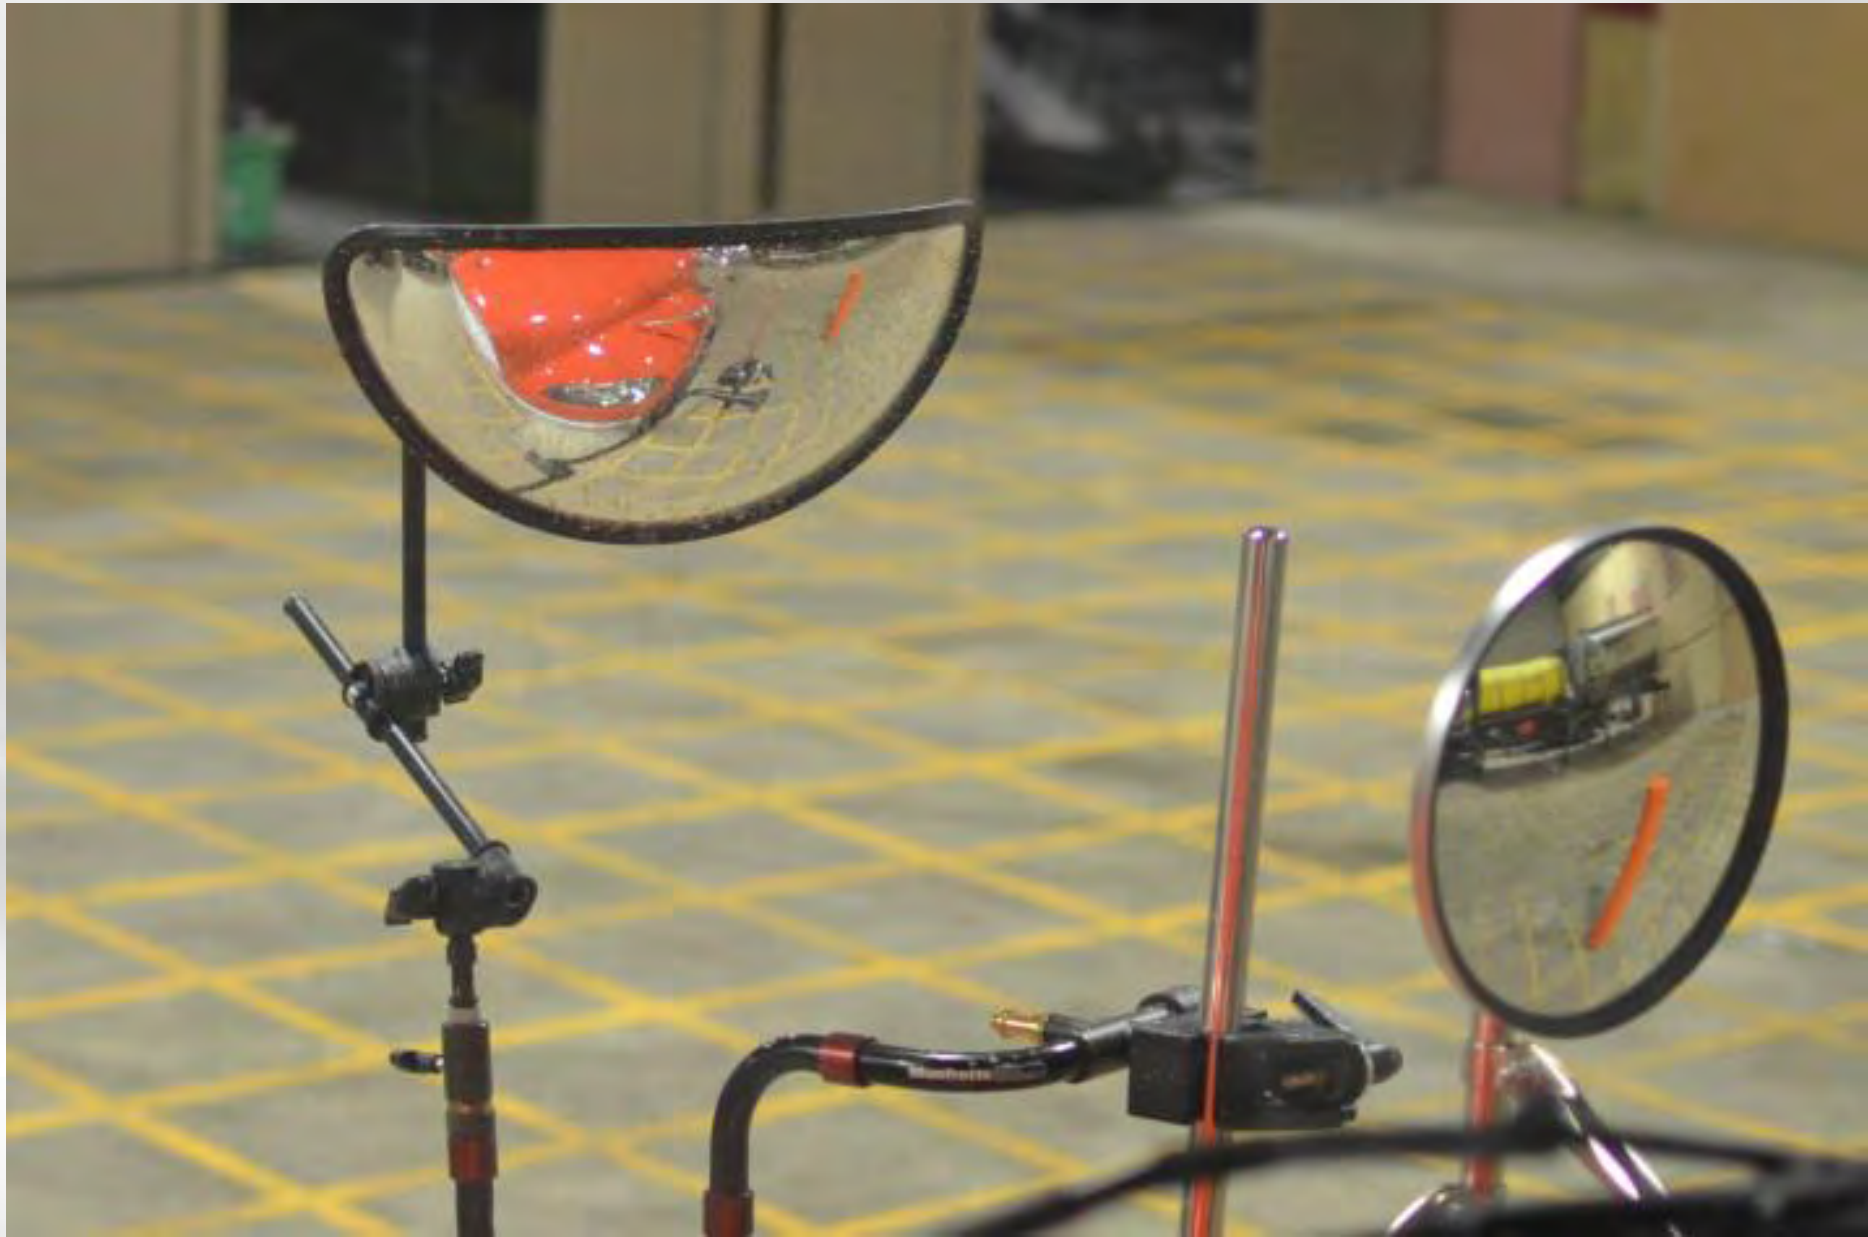
Scenario – Snowy day (messy conditions)

Day – messy conditions: Slight decrease

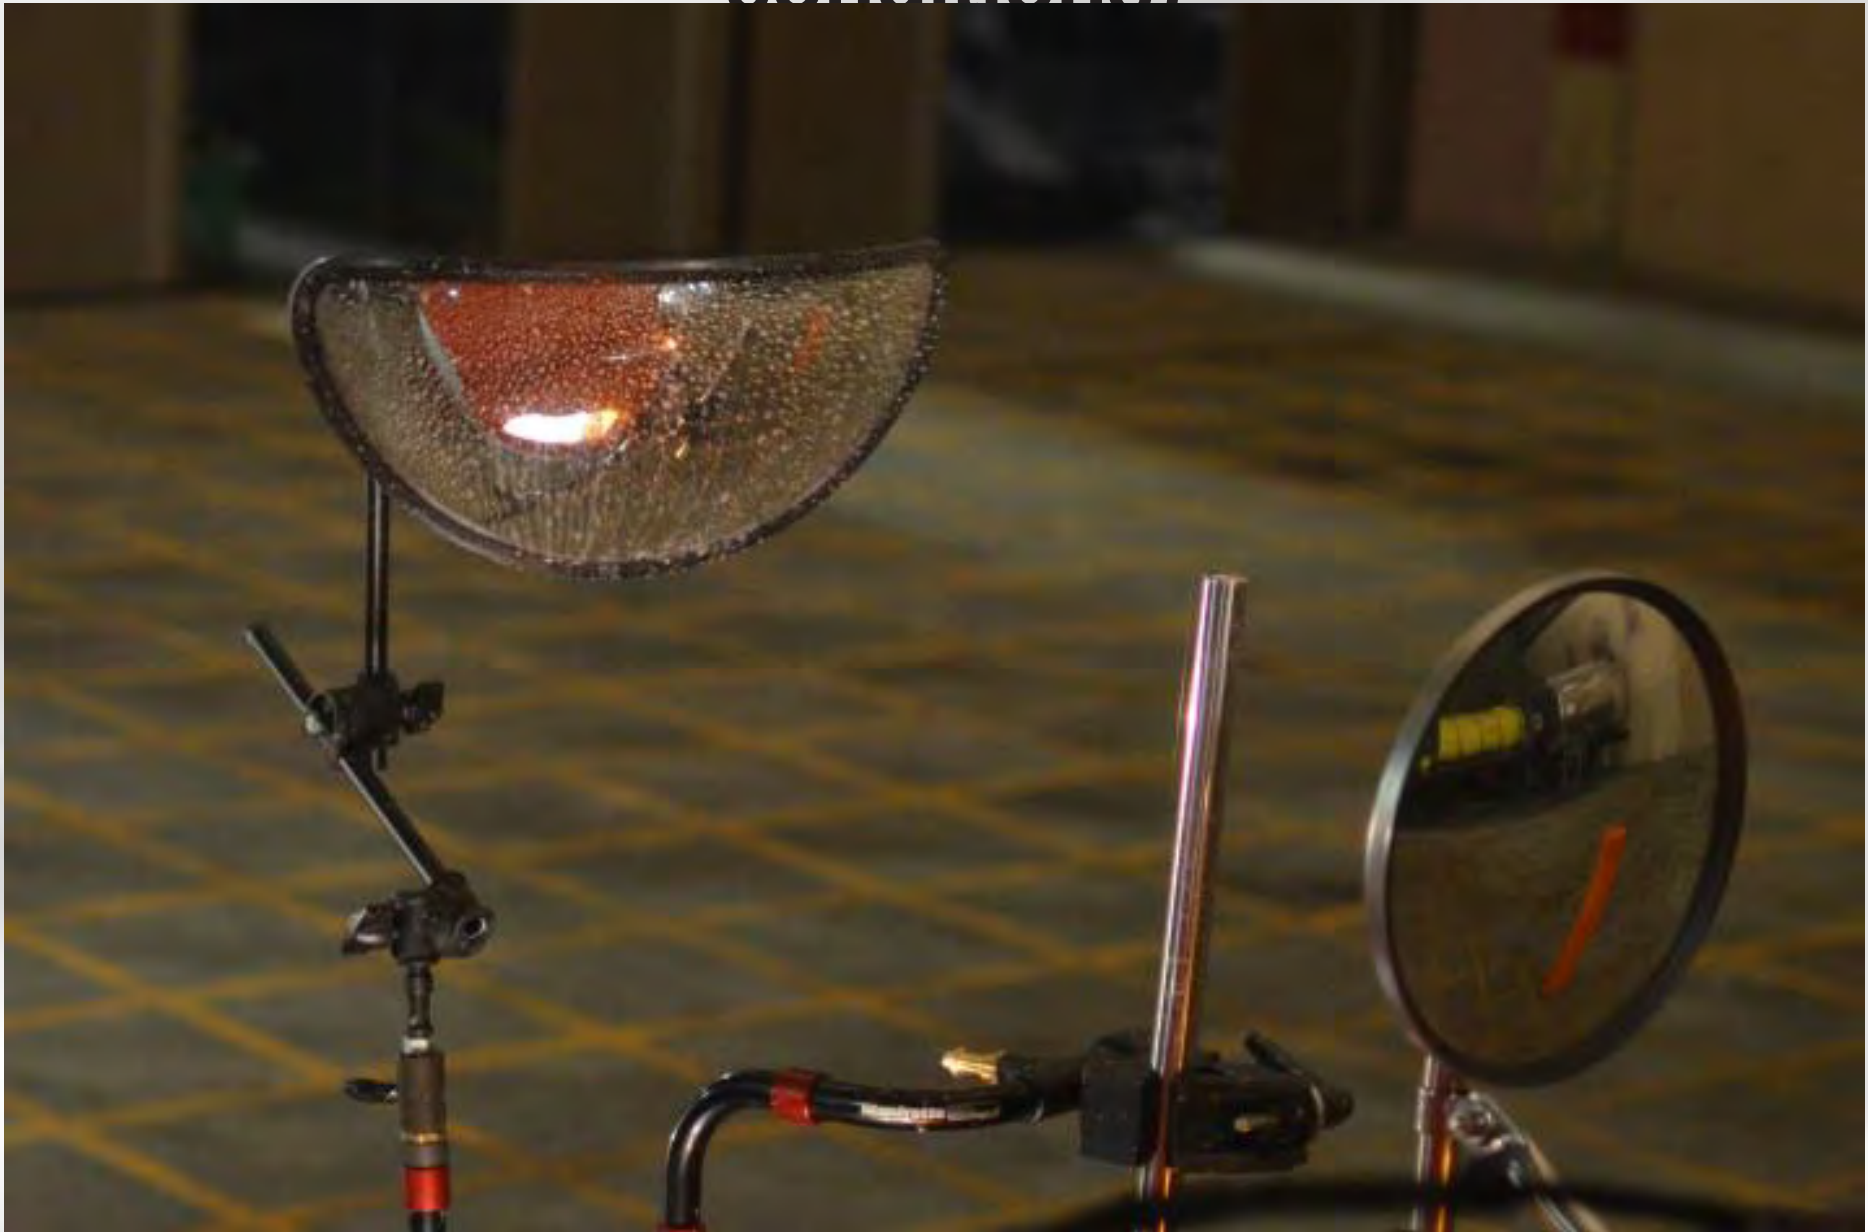
Scenario – Snowy night (messy conditions)

Night – messy conditions: Very large decrease

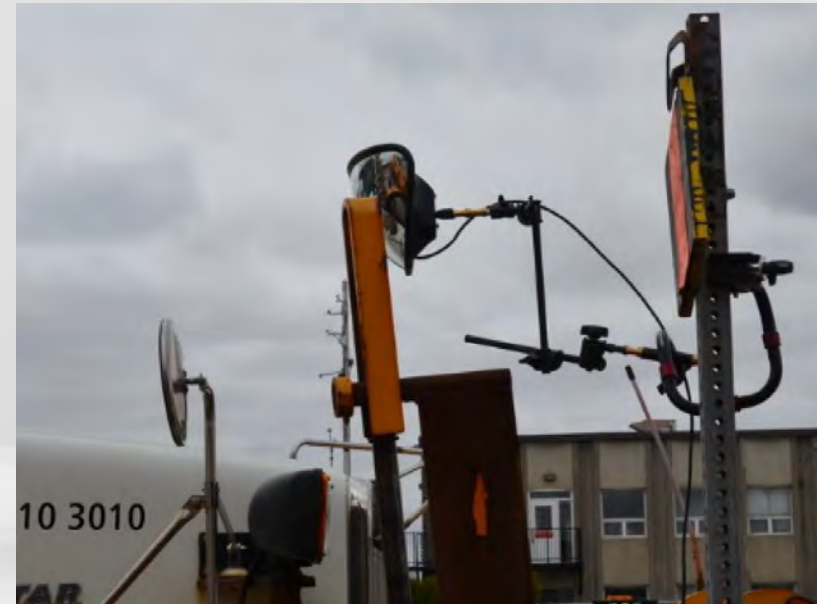
- Difficulty adjusting non-standardized mirrors
 - Attachment point not flexible enough for adjustment
- Interference with snow removal equipment
 - Move mirror
 - Check effectiveness of new position
 - Possibility of simply removing mirrors in winter

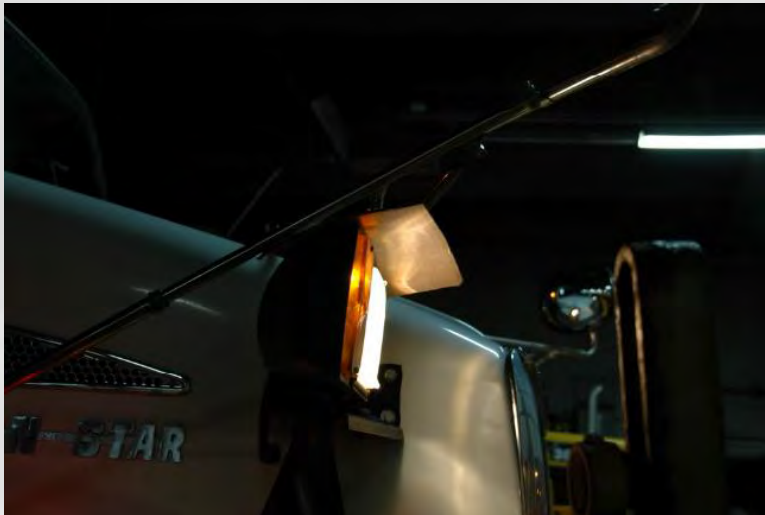
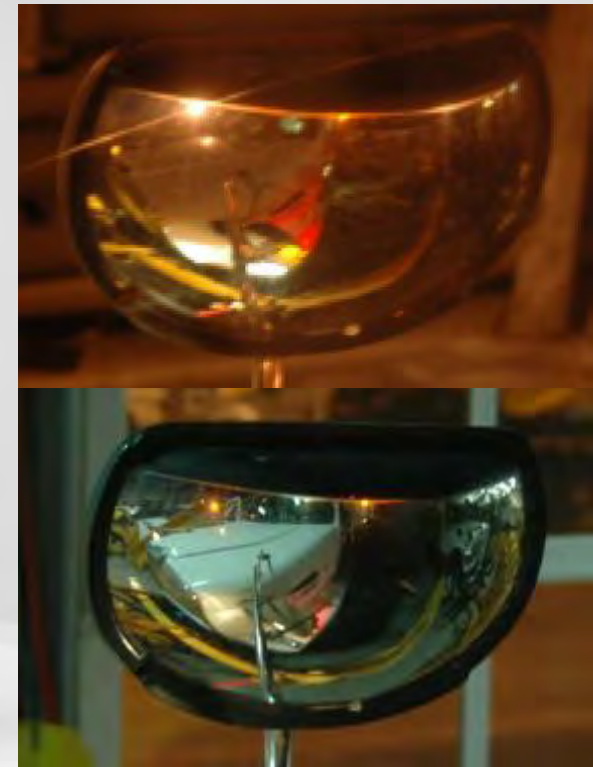
- Driver glare (discomfort)
 - ❑ Caused by auxiliary headlights
 - ❑ Solution: headlight deflector

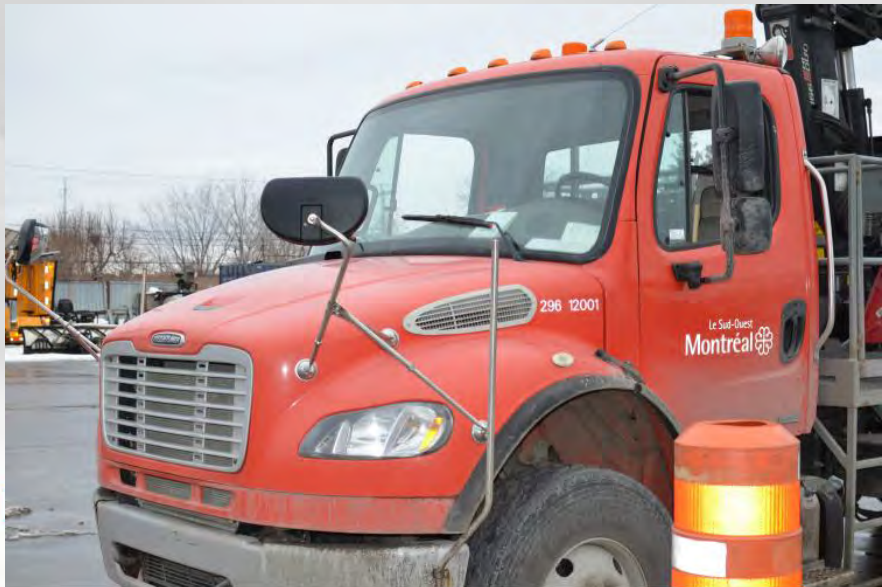
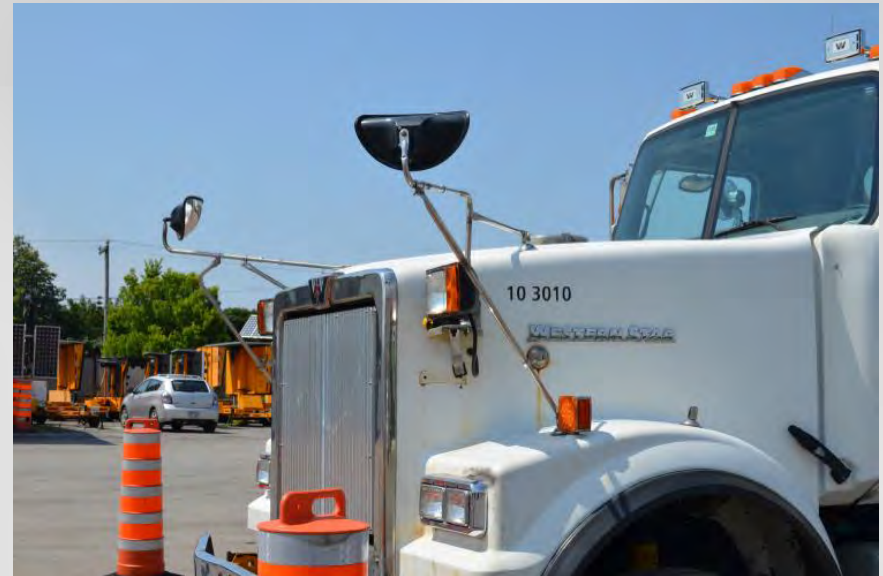
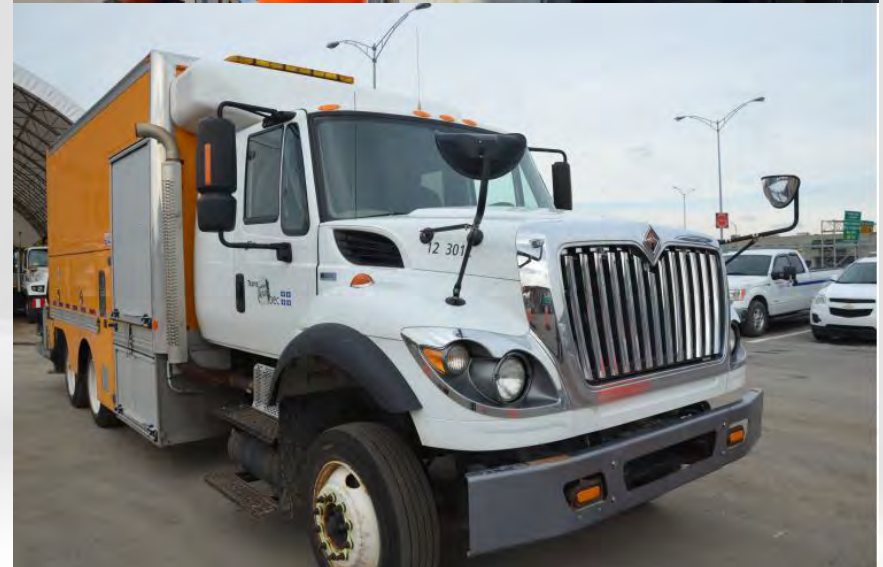
- It was possible to correctly install and adjust practically all mirrors on all types of hoods
- The suggested positioning method is valid
