Proposed solution to improve pedestrian detection in urban areas by heavy vehicle drivers

By Sébastien Bédard, Eng., M.Sc
CCMTA Annual Meeting
June 3, 2018

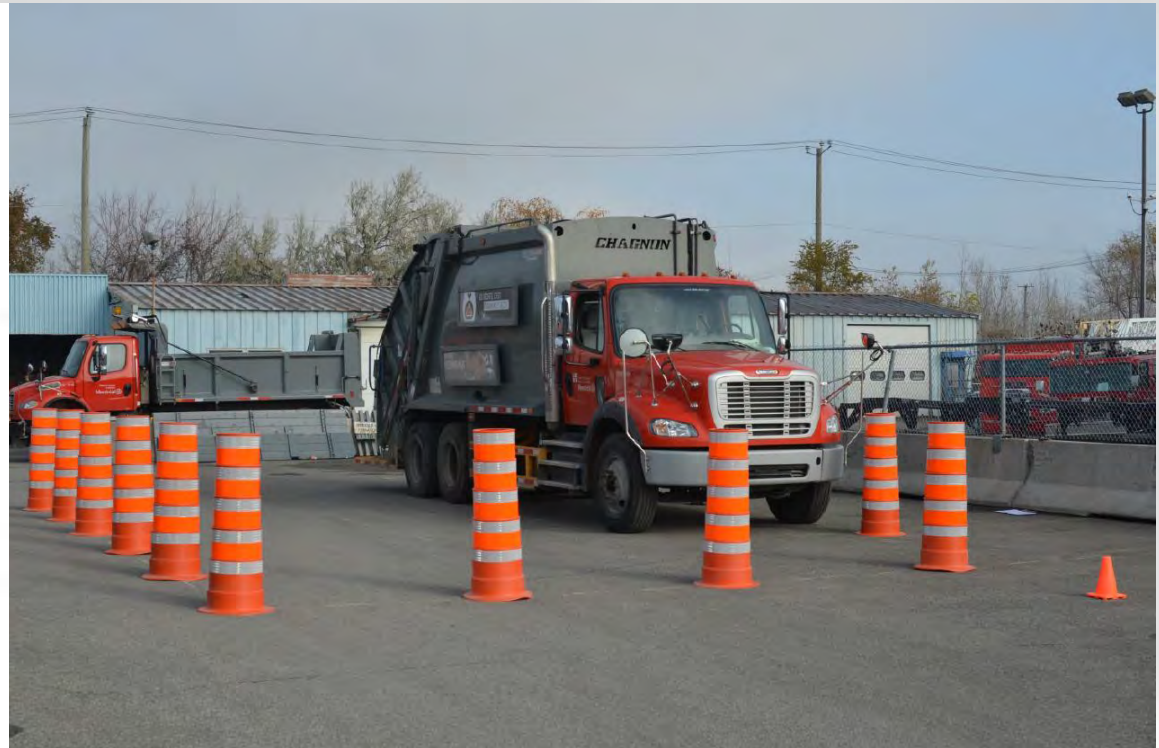
Simplified assessment method:

- TRV7 markers must be visible in mirrors
- Non-visible markers moved in
